USE OF FLAX FIBRE AS A REINFORCEMENT FOR
CONCRETE

FINAL REPORT
ADF Project # 20080103

Prepared by: Leon D. Wegner, Ph.D., P.Eng.
Associate Professor
Department of Civil and Geological Engineering
University of Saskatchewan
57 Campus Drive
Saskatoon, SK S7N 5A9

Date: November 1, 2011

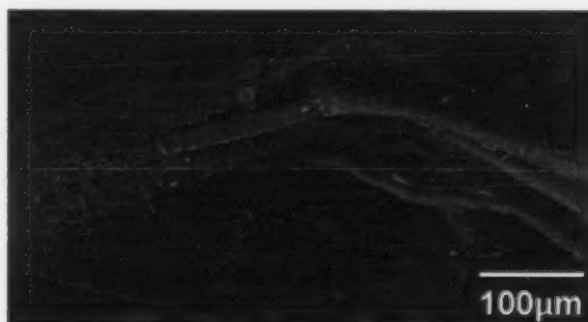
Figure 6. Scanning electron micrograph of an untreated technical fibre separating into its component elementary fibres.

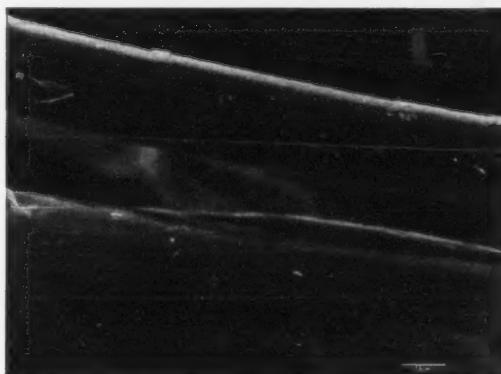
Figure 20. Scanning electron micrograph of acrylated elementary fibres after 56 days of immersion in porewater solution.

Figure 19 shows acrylated fibre after 14 days of exposure. A number of elementary fibres, presumably once forming part of the same technical fibre bundle, are seen to be separated from each other at this location, and residuals of the middle lamella material are still apparent. However, there is no evidence of damage to the surfaces of the elementary fibres. After 56 days of exposure, the elementary fibres are still apparently in good condition (Fig. 20).

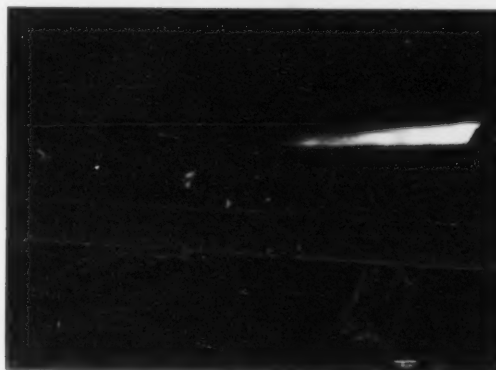
Figure 22. Scanning electron micrograph of acetylated fibres after 28 days of immersion in porewater solution.
